# Important Medical Device Advisory

## Information about Proclaim™ DRG Neuromodulation Impedance Error

March 14, 2018

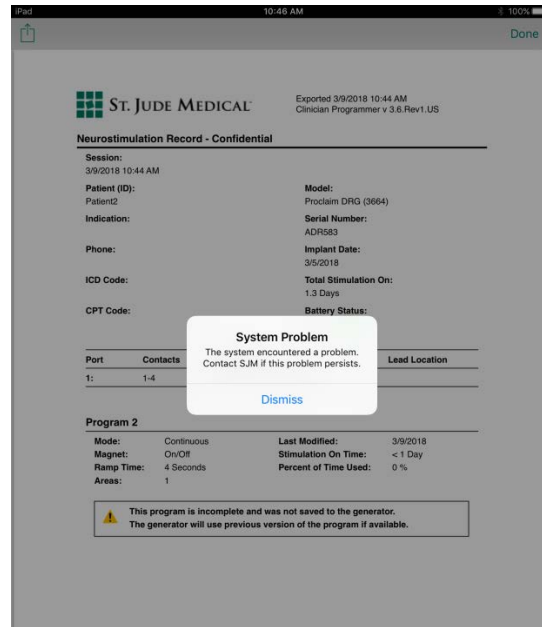
**Figure 1: Clinical Programmer Error Message**

In the affected Proclaim DRG IPGs, all three types of impedance checks are not functioning correctly. Those that are initiated from the CP or PC (scenarios 1 & 2) result in an error message stating: *“The system encountered a problem. Contact SJM if the problem persists.”* The screen views of applicable messages on the CP and PC can be found in Appendix B.

Figure 1 shows the error message on the Clinician Programmer (CP) which is displayed when an impedance check is attempted. This error message will also display on the CP or PC if entry into MRI mode is attempted.

- Do not initiate an impedance check from the Clinician Programmer
- Turn off the optional IPG Impedance Log (daily impedance check) using the Clinician Programmer
- Do not attempt to place device in MRI mode from either the Clinician Programmer or Patient Controller, as this will initiate an impedance check

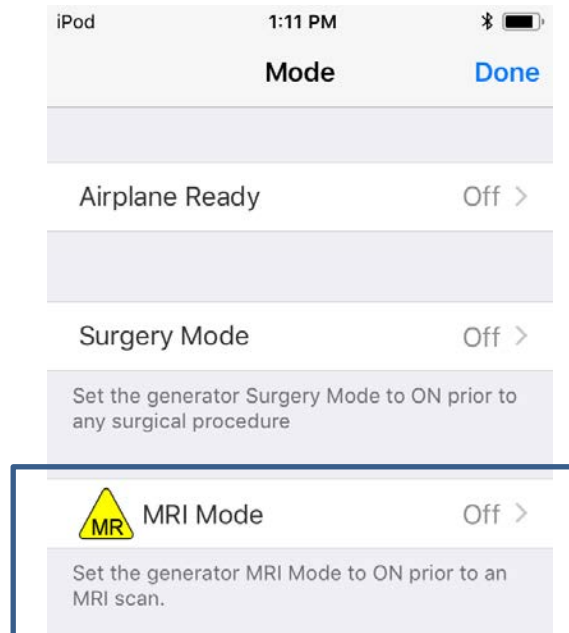
**Figure 2: Patient Controller MRI Mode Status Indicator**

Figure 2 shows where MRI Mode is found on the Patient Controller (PC) within the MODE screen. In the default state, MRI Mode is not enabled, which is displayed below. Enabling MRI Mode is not recommended until the one-time update to restore impedance check functionality is available, as this action will initiate an impedance check which may result in uncomfortable stimulation.

Impedance check functionality will be correctable with a one-time wireless update developed for the implanted devices, which is expected by September 2018. This correction will be made available to your patient by your local Abbott Representative.
