Important Medical Device Advisory

Information about Proclaim™ DRG Neuromodulation Impedance Error

March 14, 2018

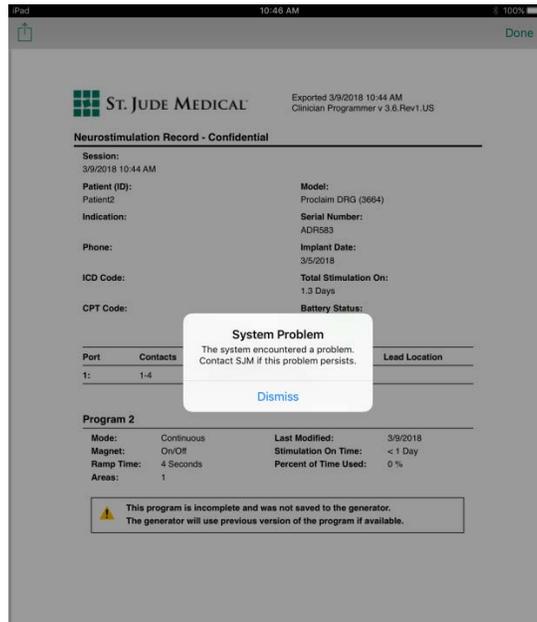
Figure 1: Clinical Programmer Error Message

In the affected Proclaim DRG IPGs, all three types of impedance checks are not functioning correctly. Those that are initiated from the CP or PC (scenarios 1 & 2) result in an error message stating: *“The system encountered a problem. Contact SJM if the problem persists.”* The screen views of applicable messages on the CP and PC can be found in Appendix B.

Figure 1 shows the error message on the Clinician Programmer (CP) which is displayed when an impedance check is attempted. This error message will also display on the CP or PC if entry into MRI mode is attempted.

- Do not initiate an impedance check from the Clinician Programmer
- Turn off the optional IPG Impedance Log (daily impedance check) using the Clinician Programmer
- Do not attempt to place device in MRI mode from either the Clinician Programmer or Patient Controller, as this will initiate an impedance check

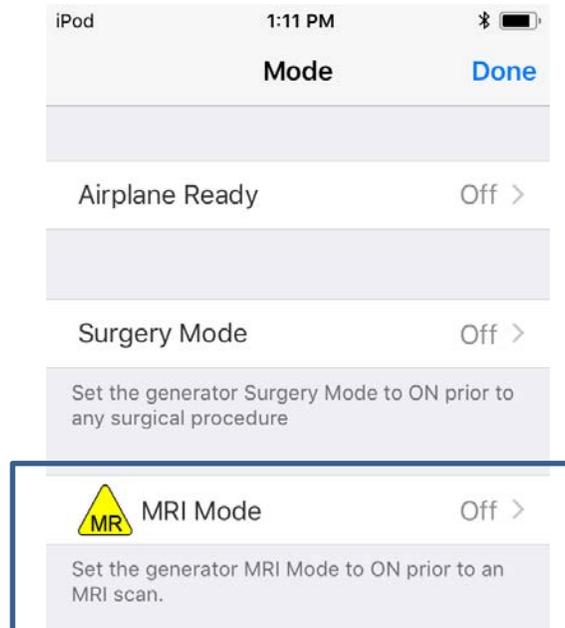
Figure 2: Patient Controller MRI Mode Status Indicator

Figure 2 shows where MRI Mode is found on the Patient Controller (PC) within the MODE screen. In the default state, MRI Mode is not enabled, which is displayed below. Enabling MRI Mode is not recommended until the one-time update to restore impedance check functionality is available, as this action will initiate an impedance check which may result in uncomfortable stimulation.

Impedance check functionality will be correctable with a one-time wireless update developed for the implanted devices, which is expected by September 2018. This correction will be made available to your patient by your local Abbott Representative.
